U.S. NAVY UNDERWATER SOUND LABORATORY  
FORT TRUMBULL, NEW LONDON, CONNECTICUT

6 TESTS OF A COATING APPLIED TO A DOME WITH  
SMOOTH FILLETS AT THE WINDOW AND TRUSS  
CONNECTIONS.

USL Technical Memorandum No. 933-385-64

This memorandum reports on the high-power transmission tests that were conducted to obtain information on what additional service might be gained from a dome coating if the voids between the trusses and the skin of the AN/SQS-26 dome are filled with a smoothing compound. The dome section that was tested was prepared by the U. S. Naval Applied Science Laboratory and is identified as USL Specimen No. 82.

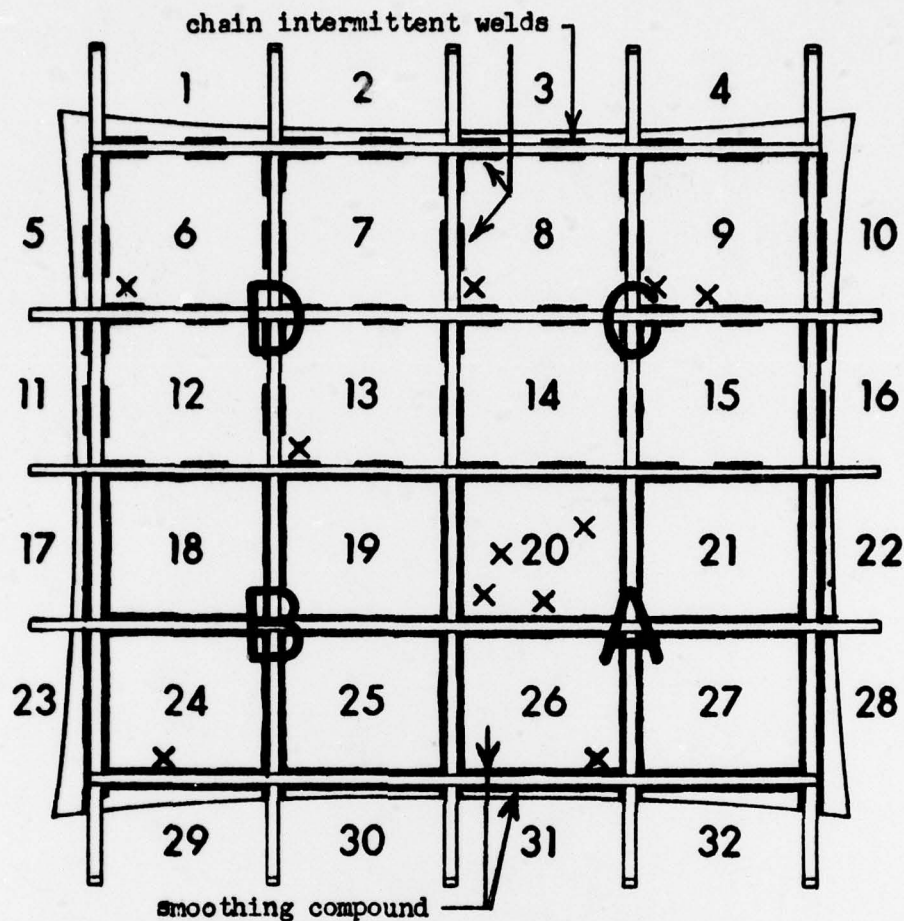
Figure 1 of USL Tech Memo No. 933-385-64

Specimen No. 32 is a 4-foot square section of an AN/SQS-26 dome that was marked for test purposes into 4 areas of equal size. Figure (1) shows: two diagonally opposite areas, designated as "A" and "D", that are coated with the standard Navy vinyl system; and two remaining areas, designated as "B" and "C", that are coated with an epoxy system. The voids between the trusses and the skin of the dome in areas A and B were filled with an epoxy smoothing compound before the coatings were applied; no smoothing compound was used in areas C and D. The coatings were carefully applied to the spaces between the trusses and the dome window. Figure 1 also shows values of coating thickness, surface roughness and salt water contact angles.

Cracks similar to those shown at the center right of figure 6 gradually developed in the antifoulant coating during the transmissions. They are approximately 0.008 inches wide, irregularly shaped and randomly located. Areas 6, 12, 20, 21 and 26 of Figure 1 show a few cracks; area 27 shows extensive cracks.

Coatings: A Standard vinyl dome paint with voids filled  
 B Epoxy paint with voids filled  
 C Epoxy paint without voids filled  
 D Standard vinyl dome paint without voids filled

Coating thickness: A and D - 0.022 to 0.027 inches  
 B and C - 0.024 to 0.026 inches

Surface roughness: A, B, C, and D at vertical and horizontal directions-  
 600 to 900 microinches rms

Salt water contact angle: A, B, C, and D: approximately 75 degrees

X : Some areas of paint damage
